***Development Zone***

## Development Zone

### Introduction

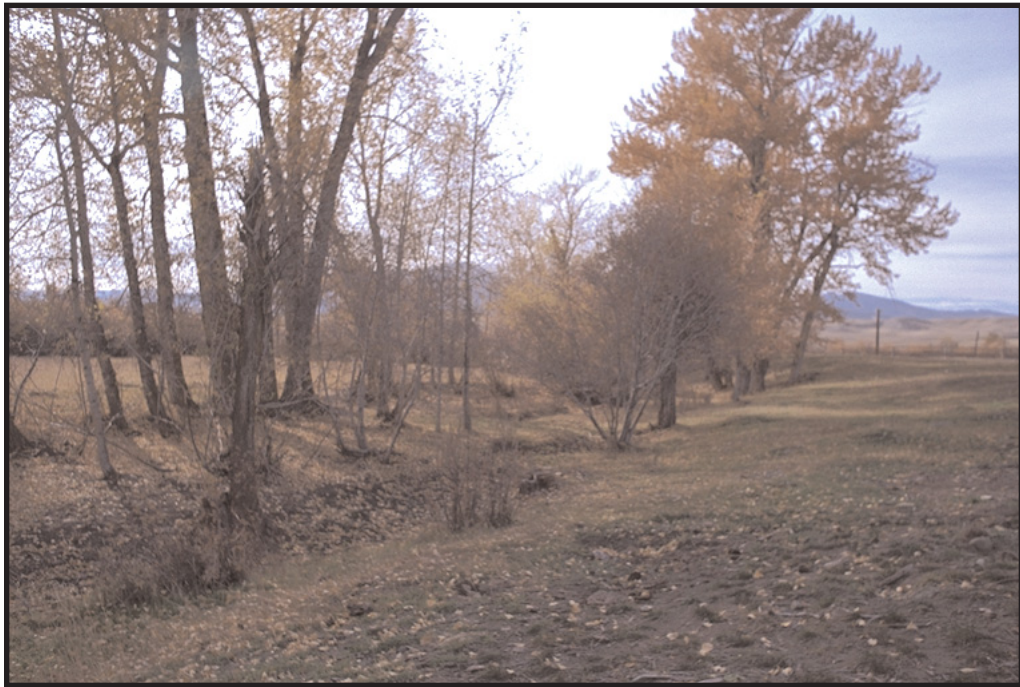
The developed land within this area is generally flat and consists mostly of very deep and well drained Beaverell loams. This area drains to Johnson Creek, which passes through the southern edge of the visitor center area. Its small riparian zone (see Photo 3-9-1), consists of Gregson loams, which are very deep and somewhat poorly drained soils.

Photo 3-9-1 : (RG-06) Johnson Creek riparian zone within Visitor Center area.

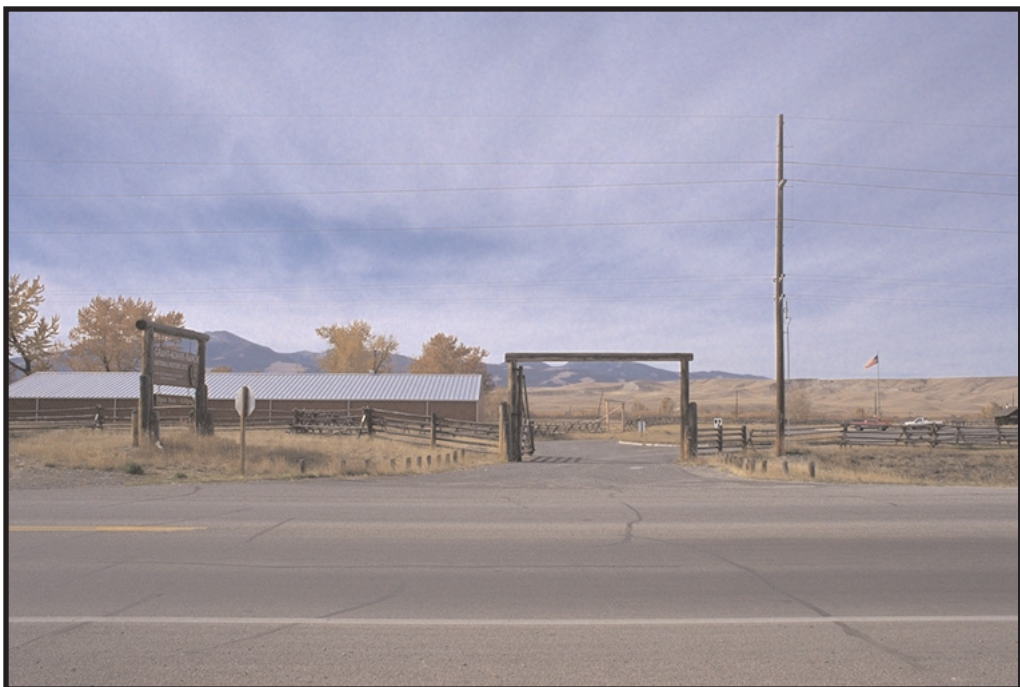
The main **Visitor Entry Drive** (see Photo 3-9-2) connects Business Loop 90 with the visitor center parking lot. This entry road and parking area are paved with asphalt. The parking lot is a continuous oblong loop with 24 90-degree angle, double loaded, center-aisle parking spaces (see Photo 3-9-3). One single row of parking is located on the northern edge and contains two handicap-accessible spaces. Two circular grass traffic islands are positioned at either end to control traffic flow (see Photo 3-9-4).

Photo 3-9-2 : (RA-15) Visitor Entry Drive off Business Loop 90.

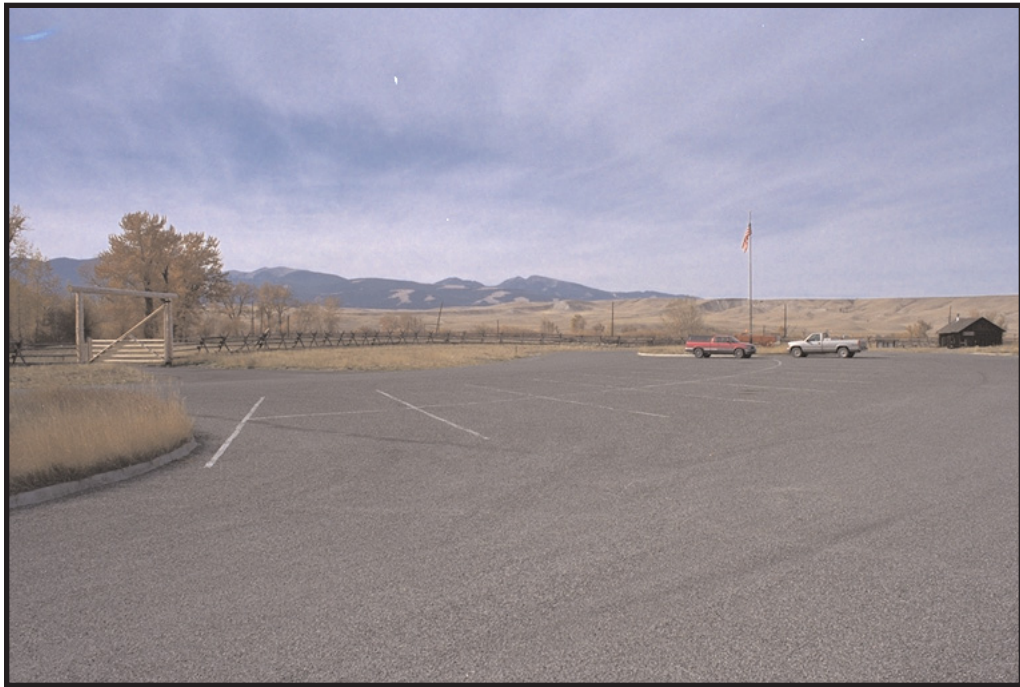
Photo 3-9-3 : (RA-21) Visitor Parking Area.

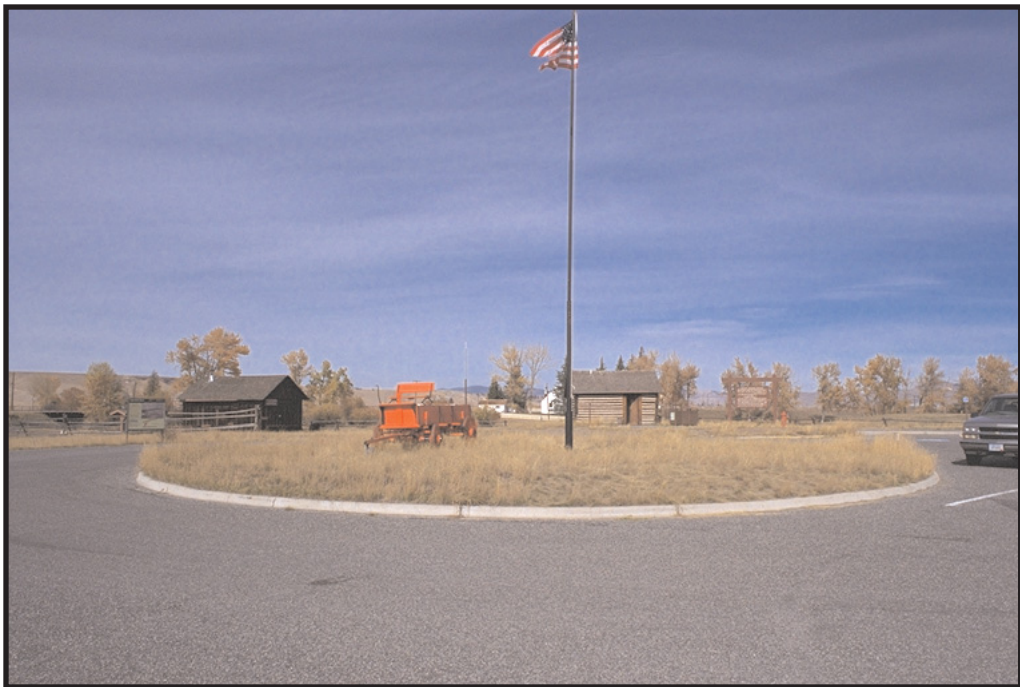
Other small scale features are located in the center of the western traffic island. These include a **flag and flagpole**, as well as a small wooden **grain wagon** (see Photo 3-9-4). This latter feature is painted orange.

Photo 3-9-4 : (RB-04) Grass traffic islands with flagpole and grain wagon.

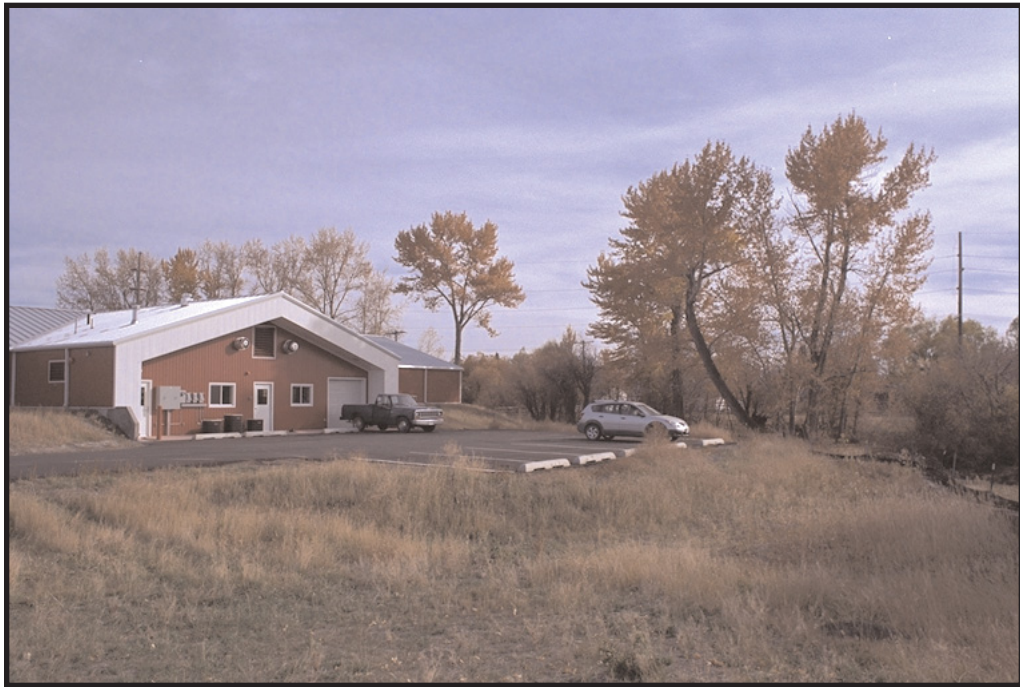
The curatorial building is accessed via an **asphalt driveway** off the southern end of the visitor parking lot (see Photo 3-9-5). Its parking area is located to the west of the curatorial building and contains five parking spaces and a loading area.

The **Curation Storage Facility (CSF)** (004), (see Photo 3-9-5) is located at the southeastern corner of the CLR study boundary, north of the Deer Lodge town limits, and east of the railroad tracks. The facility houses curated items in a temperature-controlled environment. The T-shaped,

metal pole-barn building has a short rectangular entrance ell leading into a longer, perpendicular ell which acts as a warehouse. The building has red, metal, vertical siding with a silver, standing-seam gabled roof. The main entrance, a white metal pedestrian door, is centrally located on the western end of the short office ell. This western elevation also contains two windows, a metal, roll-up garage door, a second pedestrian door, and three vents in the gable end. This entire elevation is recessed into a continuous extended wall and roofline.

Photo 3-9-5 : (RG-04) Curation Storage Facility (004), access drive, and parking area.

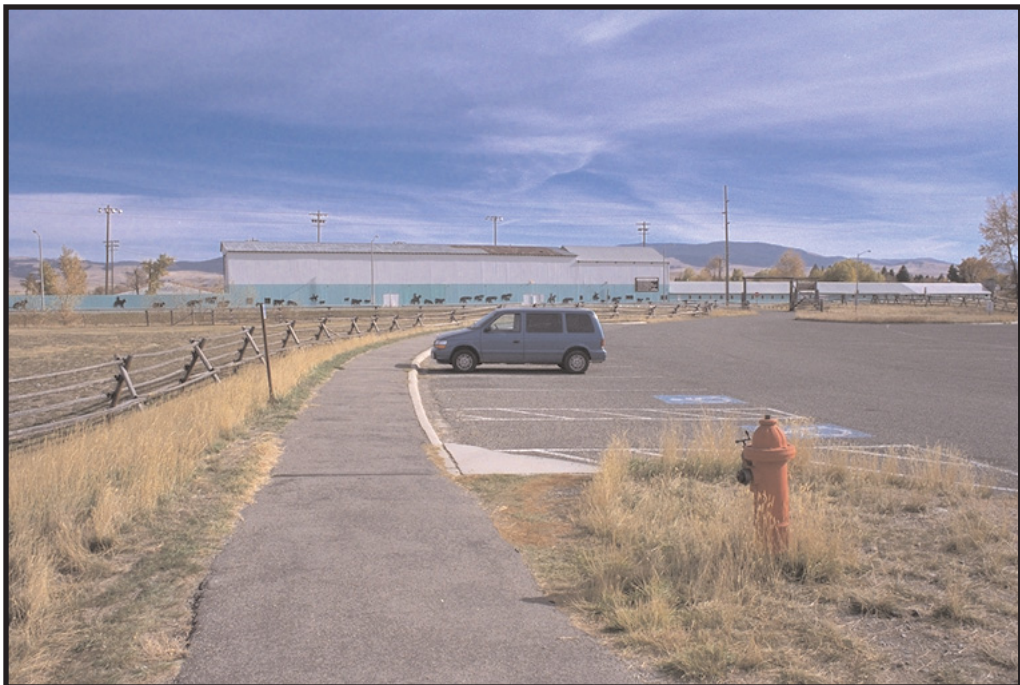
A six foot wide **asphalt sidewalk** connects the parking area with the restrooms and visitor contact station (see Photo 3-9-6). It continues underneath the railroad trestles to the home ranch complex where it terminates at the Grant-Kohrs Residence (see Photo 3-9-7). Interpretive signs are placed along the trail to educate visitors about the historic landscape and activities associated with the Grant-Kohrs Ranch.

Several other small scale features are located around the perimeter of the restrooms. These include a **fire hydrant**, **manhole cover**, **transformer**, freestanding green **metal utility structure**, and **Travelers Information Station (TIS) pole**. A **fire box** is also located on the east side of the restrooms. It is constructed of wood and measures approximately four feet wide, three feet high, and two feet deep (see Photos 3-9-6, 3-9-17, and 3-9-18).

Photo 3-9-6 : (RB-09) Asphalt sidewalk and fire hydrant.

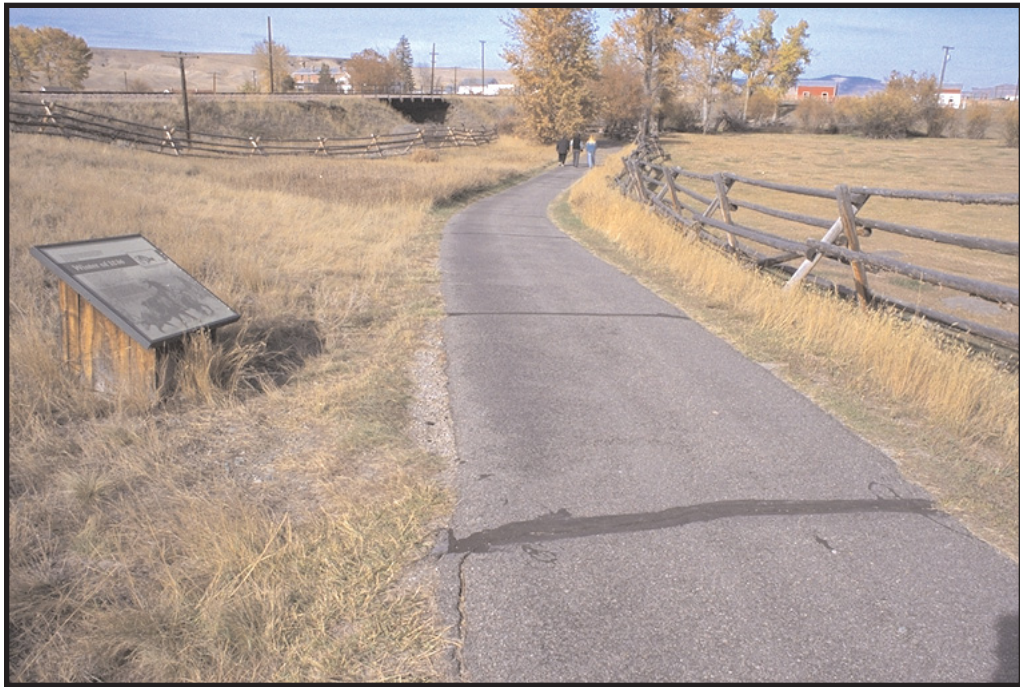
**Small interpretive signs/waysides** (see Photo 3-9-7), are located along the interpretive trail linking the visitor contact station with the home ranch complex. They appear to be constructed of fiberglass contained within a metal frame, and are mounted at an angle on a low profile wooden base.

Photo 3-9-7 : (RC-21) Pedestrian walk continues under railroad trestle to Home Ranch area. Small interpretive sign at left.

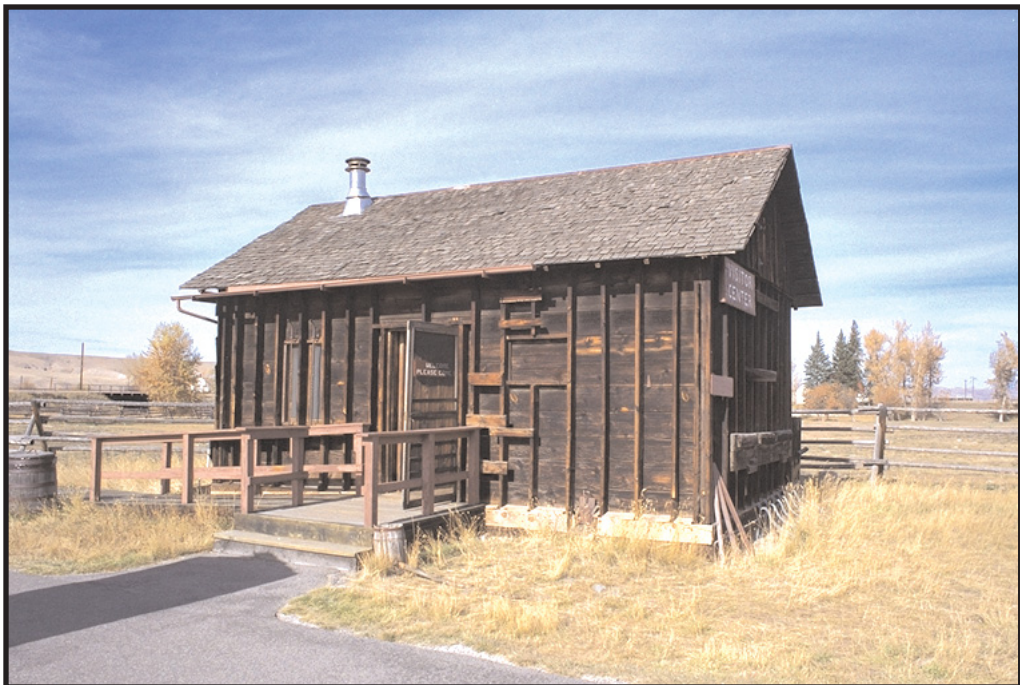
The small, rectangular **Visitor Contact Station** (002), (see Photo 3-9-8) is located northwest of the CSF. The wooden, exposed-frame building has a gabled roof covered with wood shingles. The gable ends are filled with vertical wood siding. A vent pipe sits at the western end of the roof. The main entrance and a window are located on the southern elevation. A second window is located on the west elevation. A wood-decked stoop with hand rails leads to the main entrance while a wood ramp with rails runs parallel to the western half of the southern elevation. This structure was a former granary obtained from the old Kohrs "upper ranch" site. It was refitted as a temporary visitor contact station in 1975.

Photo 3-9-8 : (RC-02) Visitor Center (002) and trash barrels.

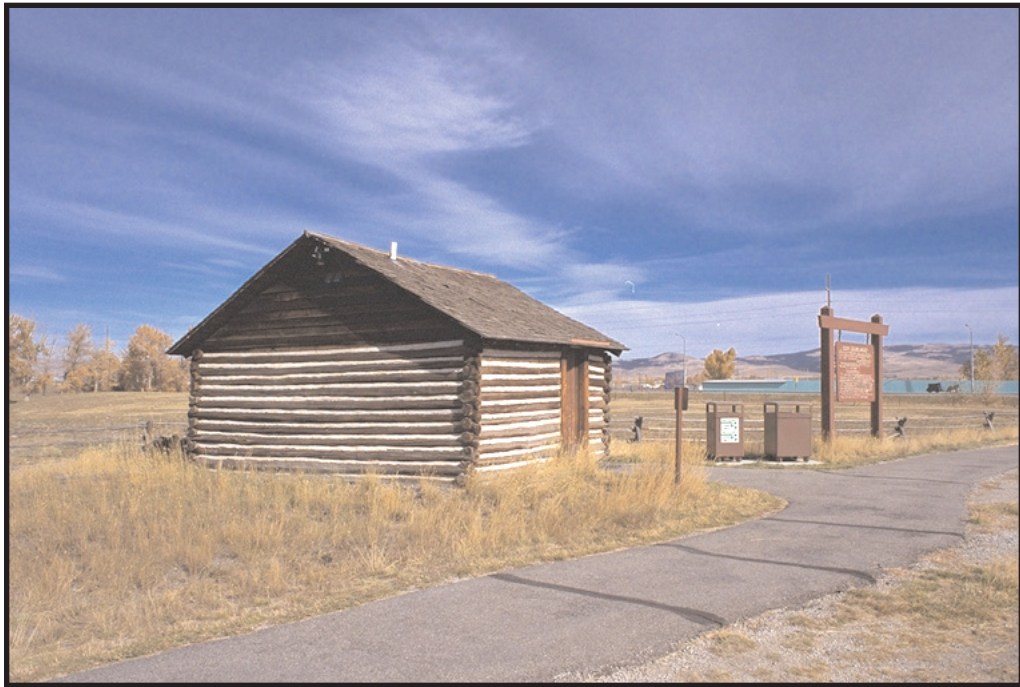
A small **Restroom** (001), (see Photo 3-9-9) of log construction, is located just east of the Visitor Contact Station. The round log walls are sealed with white lime mortar daubing. The gabled roof is covered with wood shingles and has horizontal board siding in the gable ends. The entrance consists of a single wood door offset on the southern elevation. Windows, consisting of four parallel, vertical, rectangular lights are located on the northern and eastern elevations. The building is set on cinder blocks at corners only. This structure was a log cabin, formerly used as a pig pen, and obtained from the old Kohrs "upper ranch". It was refitted as a temporary public restroom in 1975.

Two brown **metal trash cans** are located outside the restrooms. These features are square, and rest on a concrete pad (see Photo 3-9-9). Two small and one large **trash barrels** are located outside the visitor contact station (see Photo 3-9-12). These are wooden barrels with metal straps. A small wooden **picnic table** is also located to the east of the visitor contact station.

Photo 3-9-9 : (RB-14) Rest rooms (001) and trash cans.

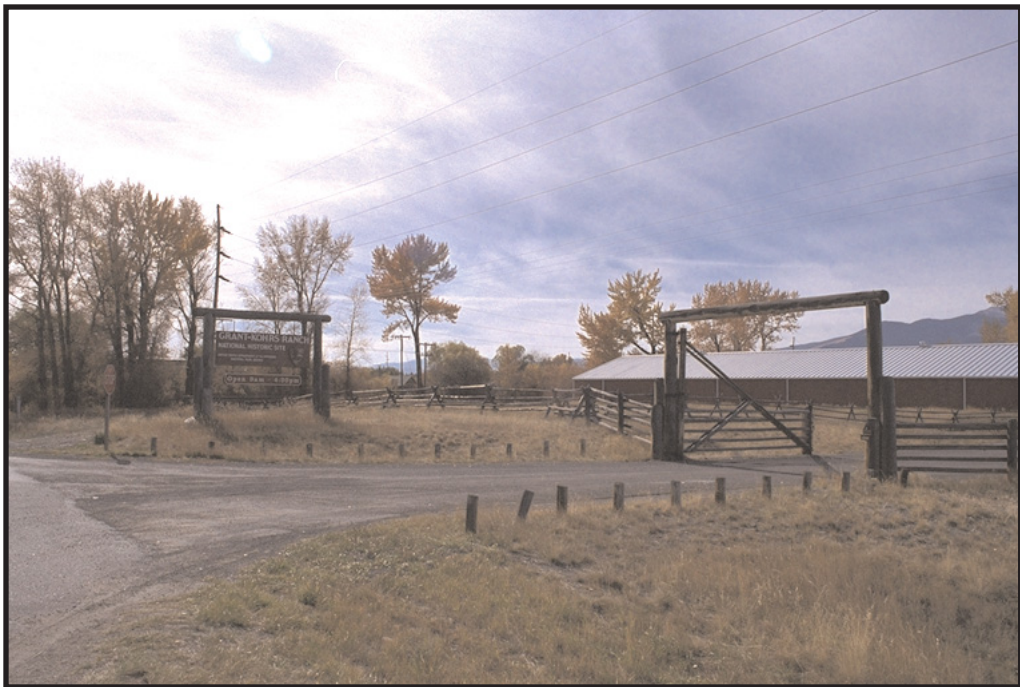
Three types of gates are used in conjunction with fencing in this landscape. The **Overhead Gate**, (see Photo 3-9-10) consists of two, tall vertical wood posts supporting a top-mounted, horizontal, wood beam. The **5-rail Braced Gate**, (see Photo 3-9-10) has a hinge-post almost twice the height of the gate and has a long, diagonal brace leading from the top of the hinge-post to the opposite corner of the gate. This brace prevents and corrects sagging. These two types of gates are used in various combinations; the overhead gate supporting the braced gate and the braced gate supported only by the adjacent fence. In addition, adjacent to the railroad tracks along the paved path to the ranch, two overhead gates are connected by two extra top beams to form a square structure. The path passes beneath from east to west while two braced gates are located on the north and south sides of the structure.

Other small scale features include several wooden entrance **bollards** located on either side of the visitor entry drive (see Photo 3-9-10). These bollards appear to be constructed of cut logs (approximately 4" in diameter) set directly into the ground. A small **wooden bench** is located along the interpretive trail. It is mounted on four wooden posts.

Several signs are located throughout the Development Zone area. These include the large wooden **entrance sign**, which is suspended by chains from an overhead gate (see Photo 3-9-10). This gate is constructed of two, tall vertical wood posts supporting a top-mounted, horizontal, wood beam. This sign is located on the southern side of the visitor entry drive. Other signs consist of the following:

Photo 3-9-10 : (RA-12) Overhead Gate with 5-Rail Braced Gate, Entry Sign, and Entrance Bollards.

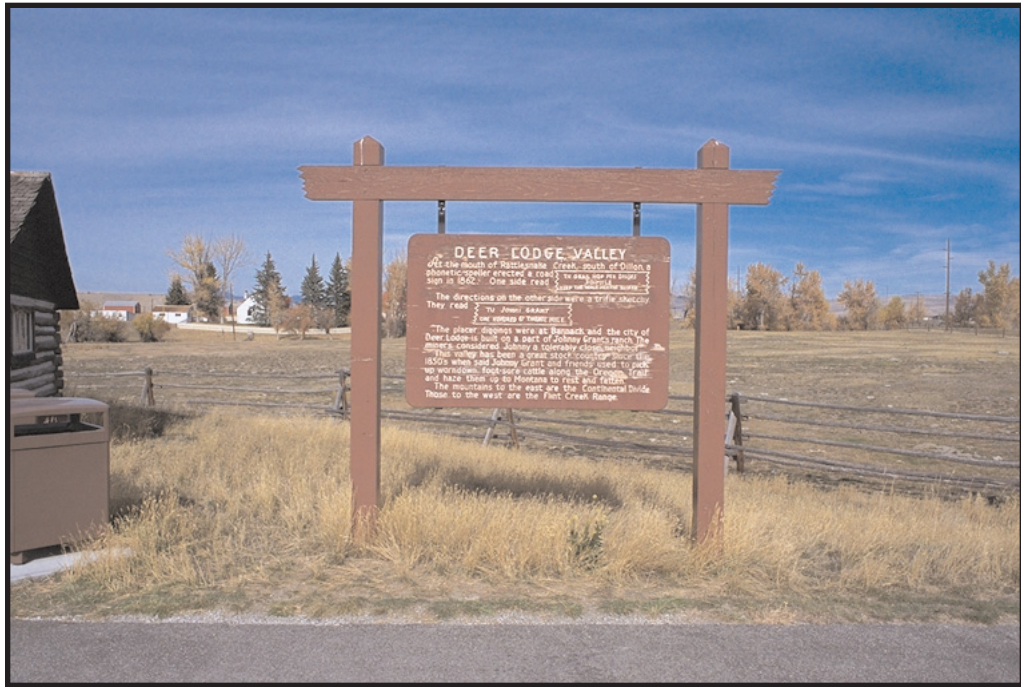
The design of the **Deer Lodge Valley** sign mimics the historic overhead gates found throughout the ranch (see Photo 3-9-11). It is constructed of two, approximately 10 foot high square wooden posts supporting a top-mounted, horizontal square wood beam with notched ends. This feature is constructed of milled lumber and is intended to look rustic. A wooden sign describing "Deer Lodge Valley" is suspended from metal hooks. Present during the field visit, this sign was removed in 2003.

Photo 3-9-11 : (RB-8) Square Wood Post and Beam sign (removed).

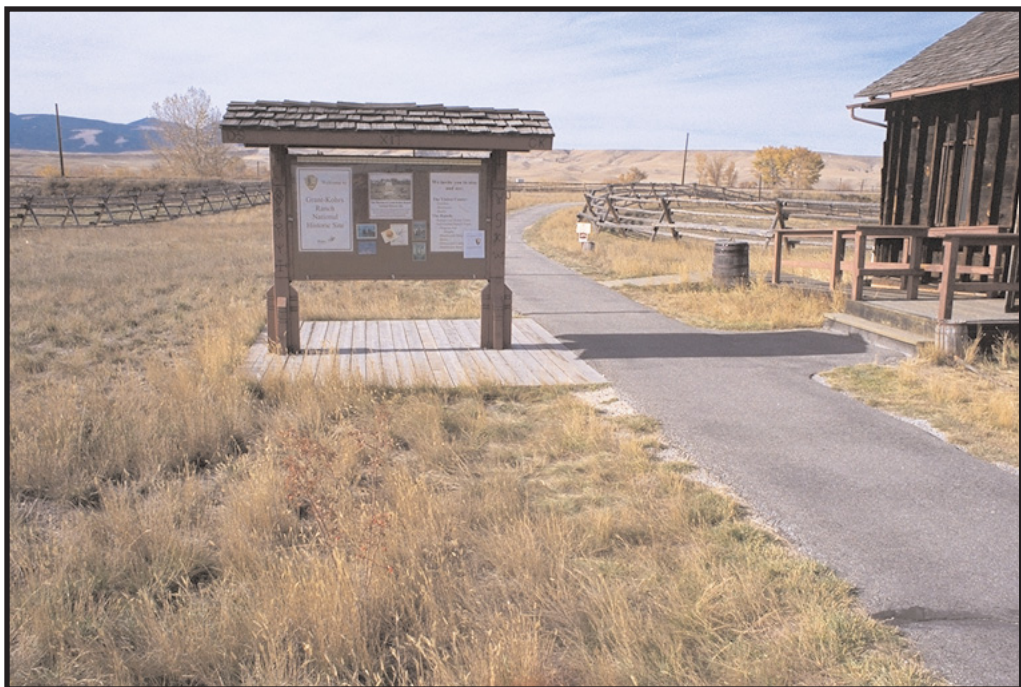
A small **mounted informational kiosk** (see Photo 3-9-12), is located directly in front of the visitor contact station building. It is mounted on two braced milled wooden posts, and is protected from the elements by a small gabled wood-shingled roof support. This feature is approximately 6 feet high.

Photo 3-9-12 : (RC-1) Mounted Information Kiosk.

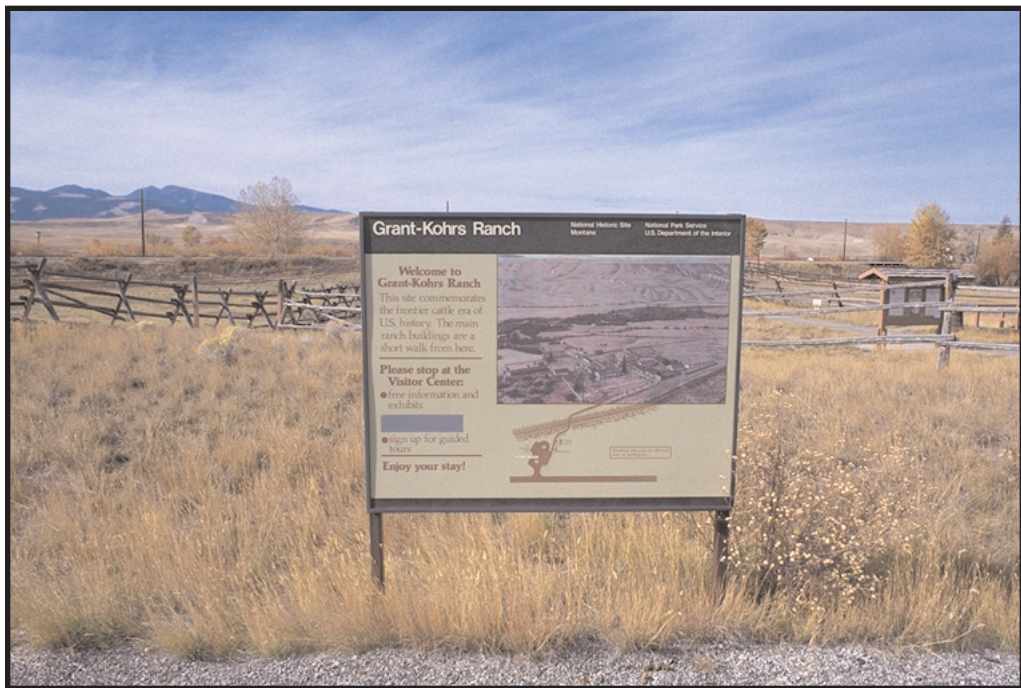
A **large interpretive sign** (see Photo 3-9-13), is constructed of imbedded fiberglass and vertically mounted in a metal frame. It measures approximately four feet high by six feet wide, and is located at the north end of the visitor parking lot. This sign welcomes visitors to the Grant-Kohrs Ranch and provides site orientation.

Photo 3-9-13 : (RB-16) Large Interpretive Sign

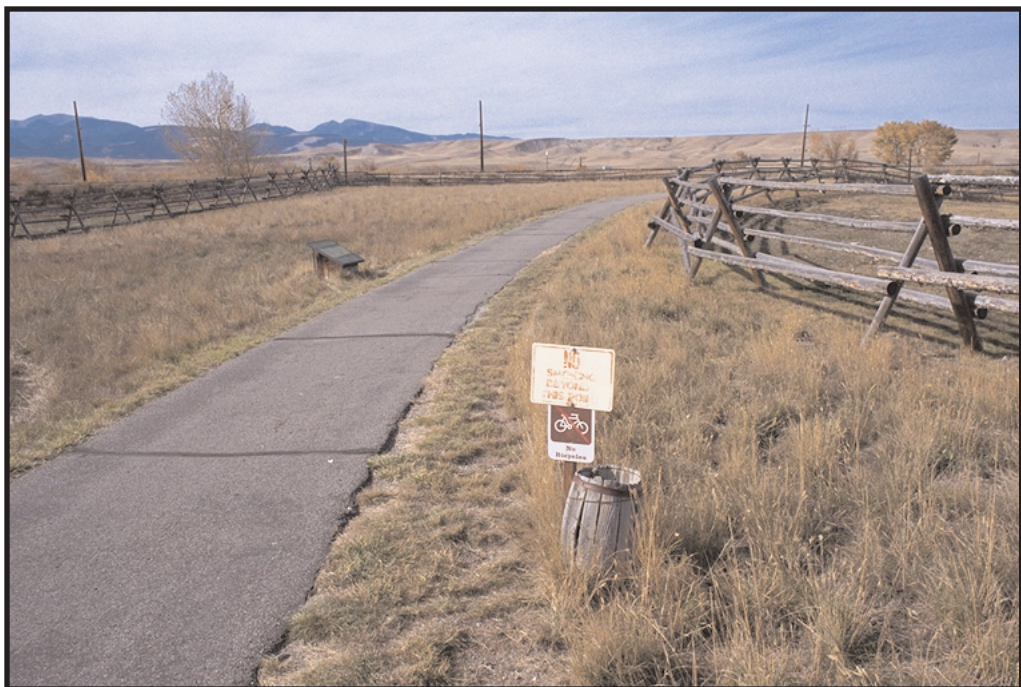
**Small informational signs** (see Photo 3-9-14), communicate the rules and regulations of the park, such as no bike riding, no smoking, no dogs, etc. They are small metal signs of varying sizes and materials, mounted vertically on small wooden posts.

Photo 3-9-14 : (RC-7) Small informational signs.

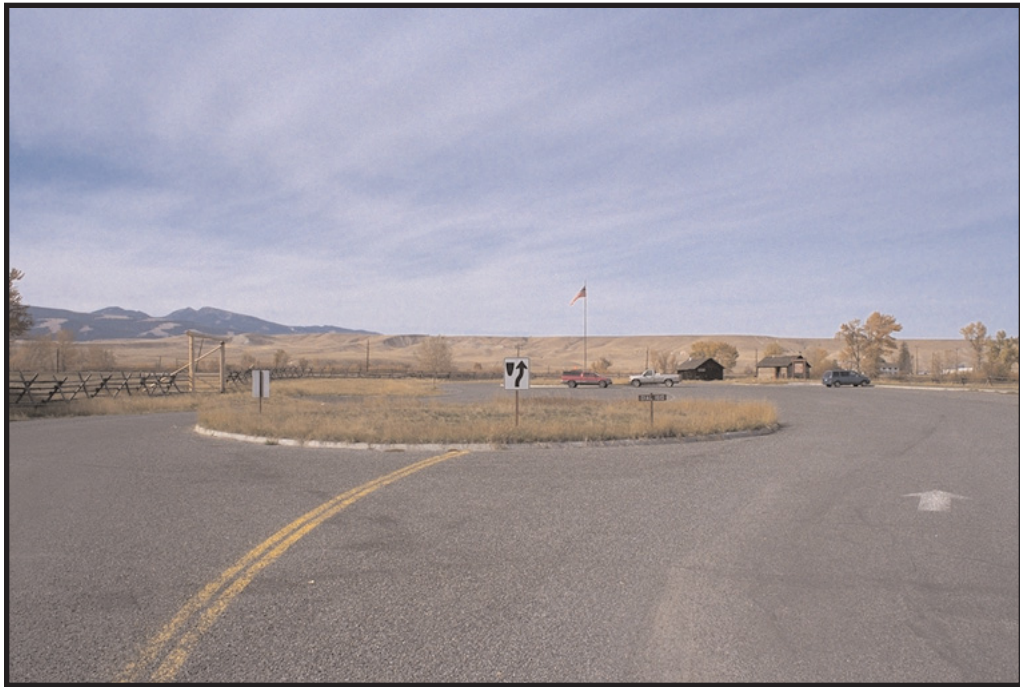
**Wayfinding signs** provide information concerning pedestrian and vehicular direction. These are typically metal signs mounted vertically on metal posts (see Photo 3-9-15).

Photo 3-9-15 : (RA-19) Wayfinding Signs.

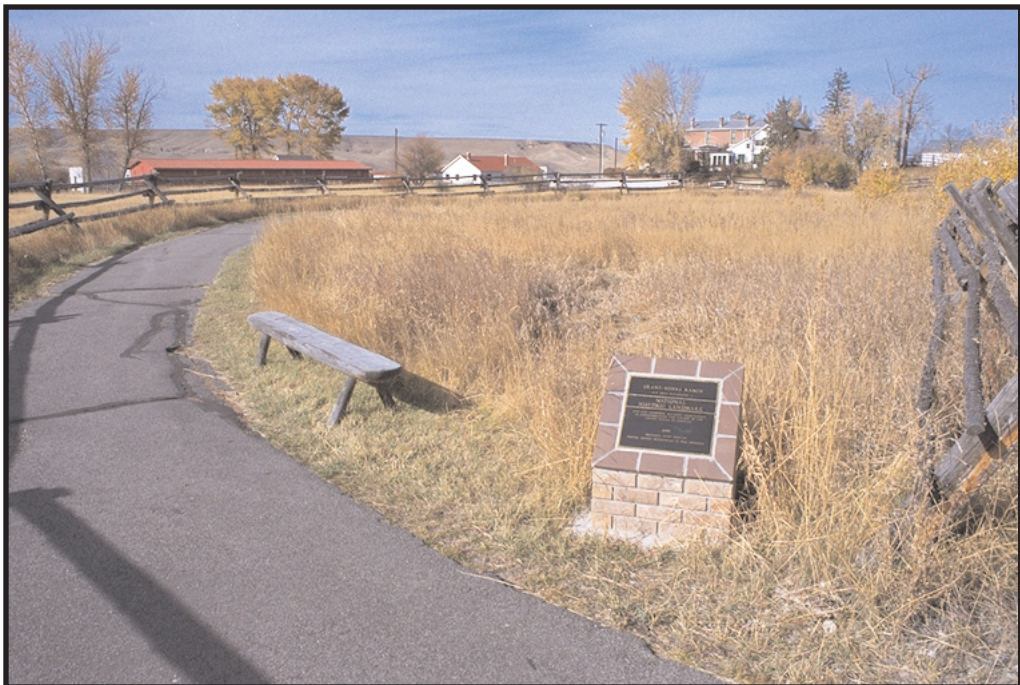
A **metal plaque** marking the site's National Historic Landmark status is mounted on a brick and mortar base, approximately 11.5-inch square base (see Photo 3-9-16). The 15-inch by 16-inch

bronze sign is mounted at a 45-degree angle and is located along the interpretive trail. This feature was added by the NPS in 2000.<sup>2</sup>

Photo 3-9-16 : (RD-6) Metal plaque and wood bench.

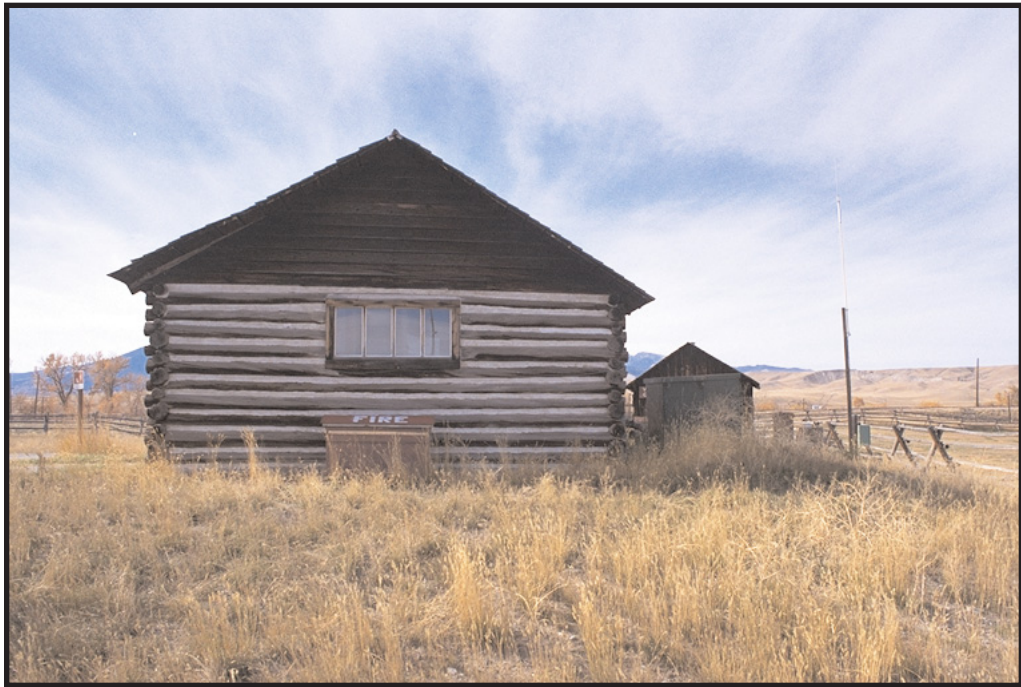
Photo 3-9-17 : (RB-11) Fire box and transformer.

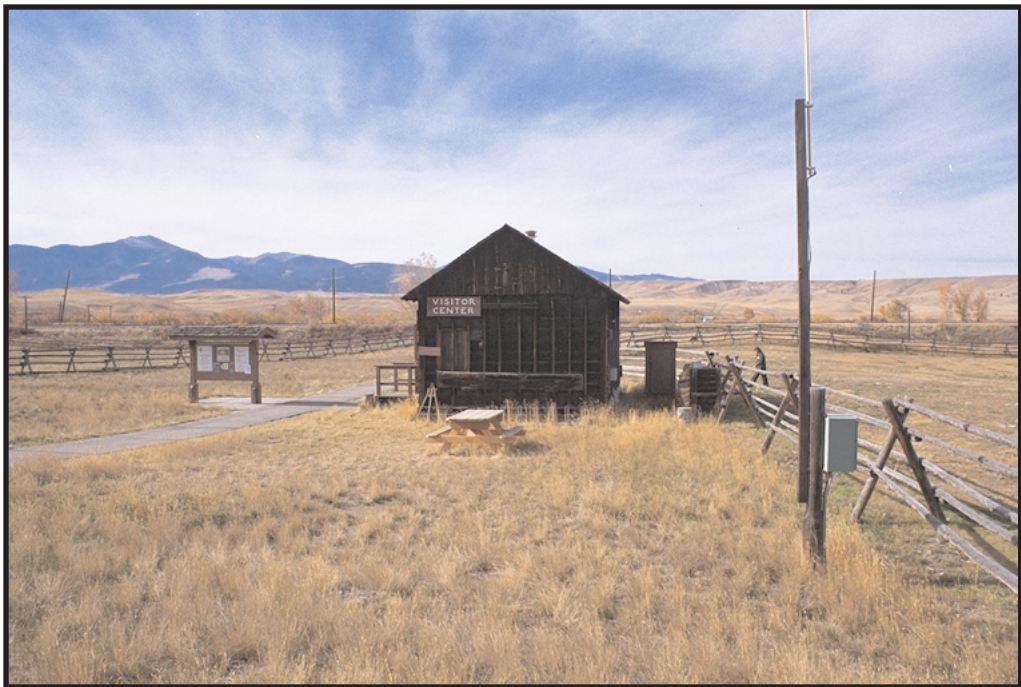
Photo 3-9-18 : (RB-12) TIS pole, utility structure and picnic table.
